Collaborative Approach To Energy Responses

Captain Chris Greene
Seattle Fire Department
Engine Co. 25 – Capitol Hill

Seattle Fire Department

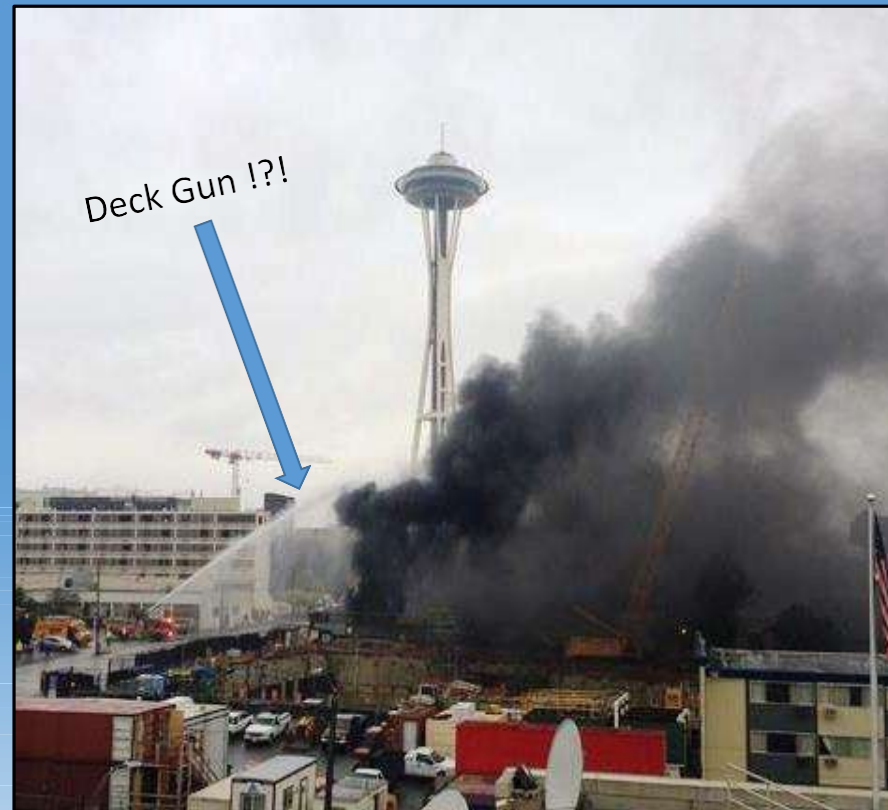
BROAD ST. SUBSTATION FIRE – Seattle, WA

- Originated in High Voltage Capacitor Bank (in a Substation)
- Initial SFD Engine Co. applied H₂O via deck gun
- Poor communication between SFD & SCL
- Poor Tactics
- Recognized need for better communication

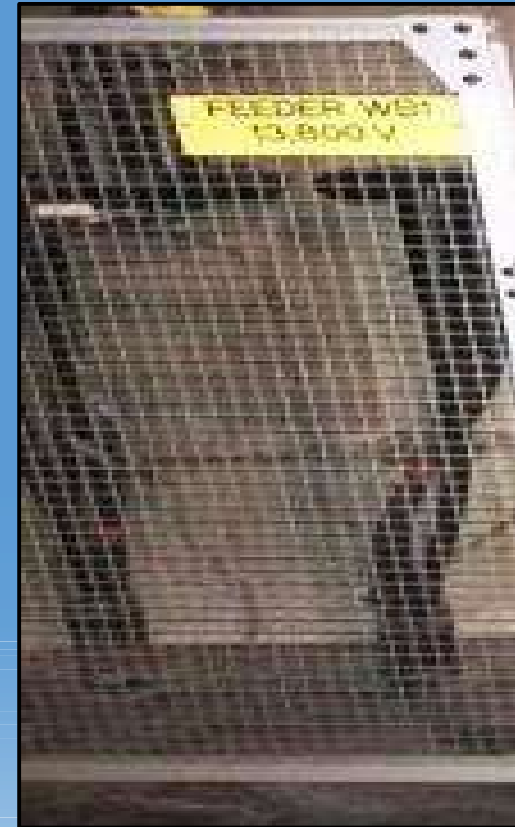
The “Light Haze” was found in this secured access area, behind a locked grate.

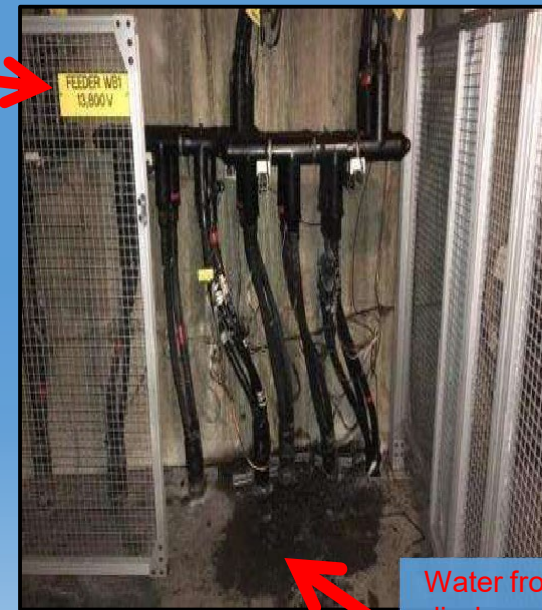
- 13,800V / Feeder Sign
- Power loss reported in Building
- Secured Access to area
- Large Diameter Electrical
- Smoke and Signs of Burn Through. "Fault"

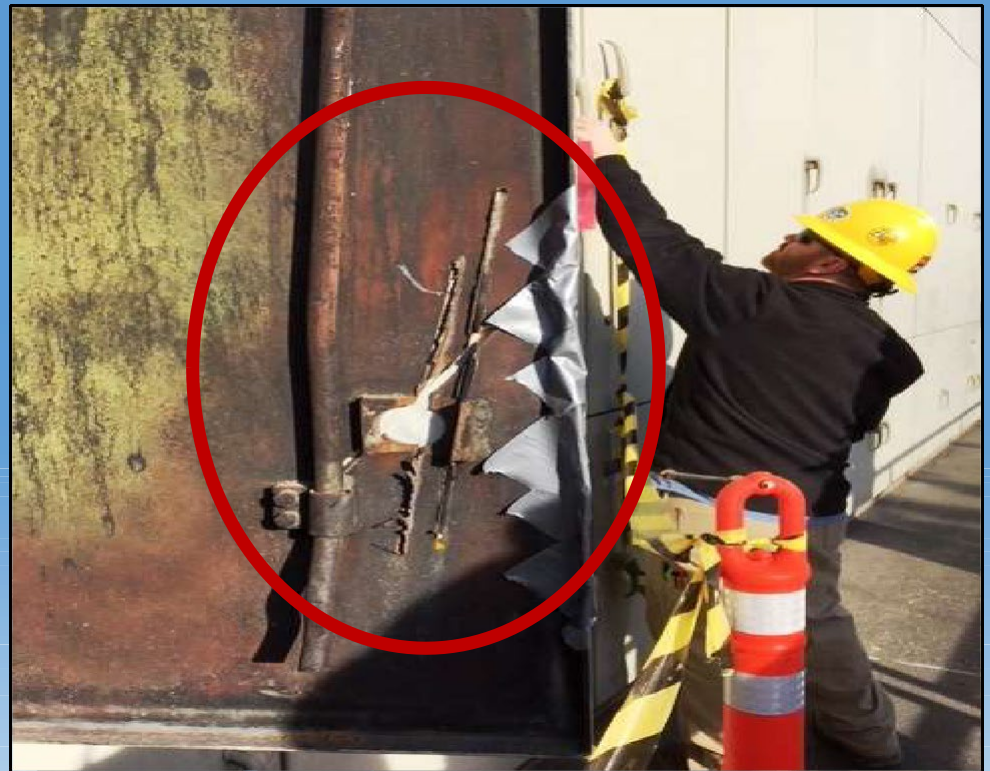
BROAD ST. SUBSTATION FIRE – Seattle, WA

- 26Kv Switch Gear
- Initial SFD Engine Co. stretched hoselines
- Poor Tactics
- **Very Dangerous Tactics !**

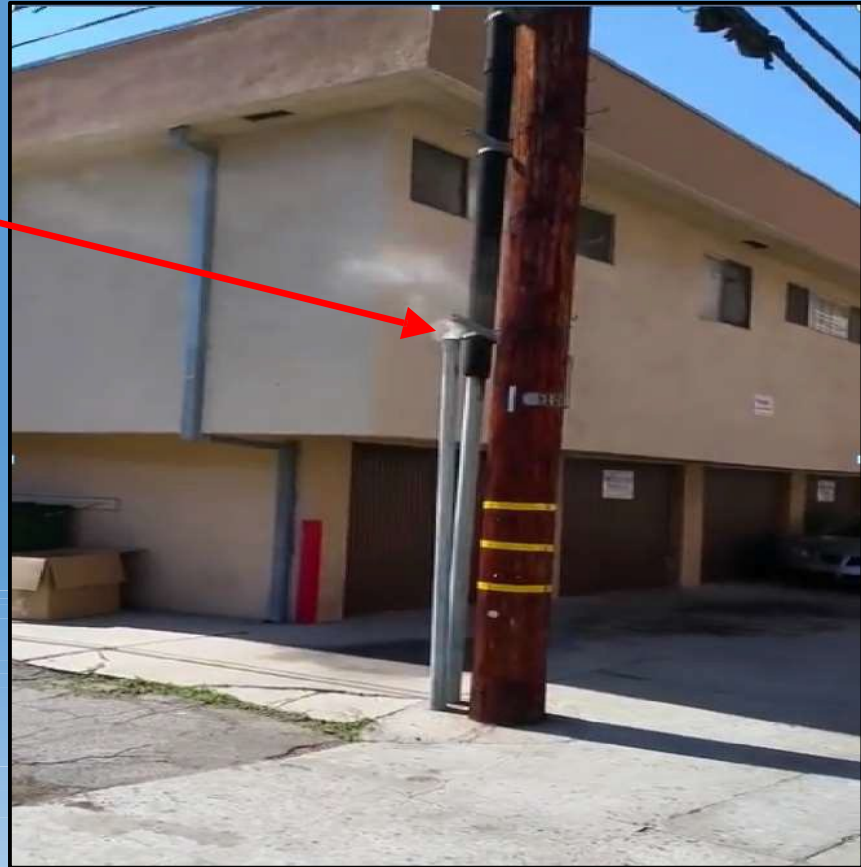
Tunnel Vision...

- Keep your eye on the decommissioned conduit stack attached to the utility pole
- What do you think is going on??
- How would you investigate this fire problem??

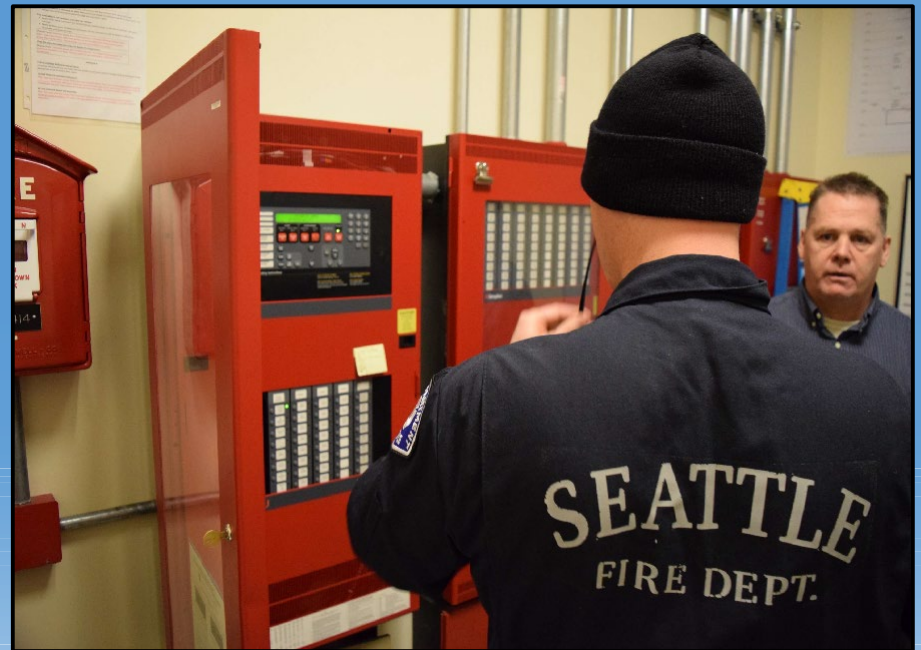
Switchgear Fire – Boston, Ma

- Panel Indicated AC Power Loss
- Generators operating created confusion regarding power loss to this building
 - *Egress lights??*
- Initial Detector Activation was in the basement

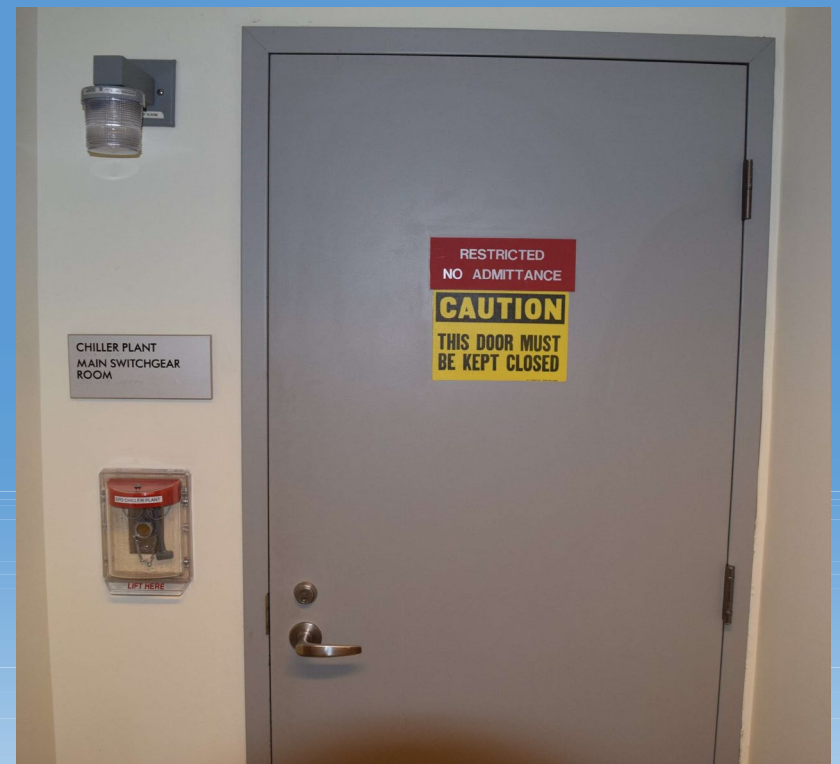
Switchgear Fire – Boston, Ma

- Light illumination = problem in this room
- Switchgear = Unusually high electrical concerns
- Electrical Infrastructure for this building
- No other signs indicating Electrical Hazards

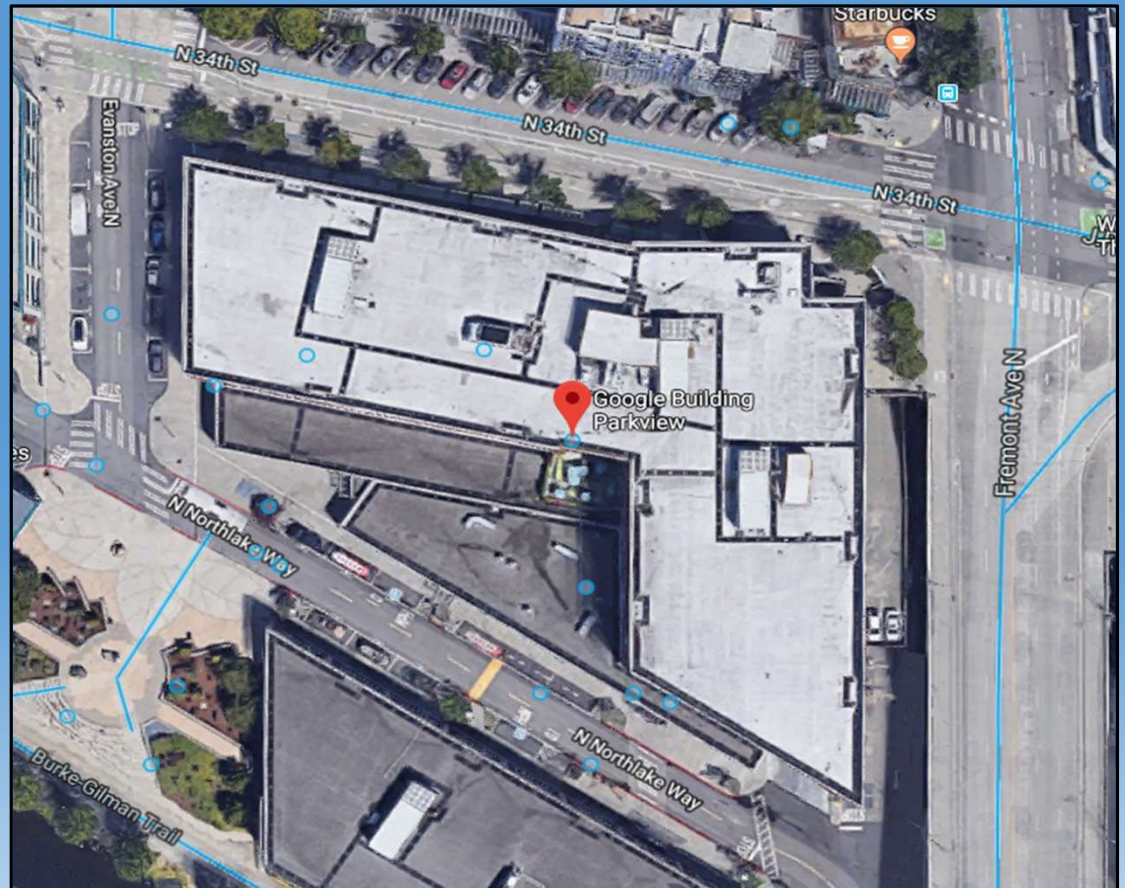
SFD Switchgear Fire - 04/18/2019

- April 18, 2019 – 08:53
- AFA – E9/L8
- 501 N 34 Street (Fremont)
- Engine 9 Short Report:
 - Power loss
 - Bang
 - Elevator entrapment
- Updated Report
 - Hazard Recognition
